Aso-Choyo-ohashi Bridge

The Aso-Choyo-ohashi Bridge is a four-span continuous PC rigid-frame bridge constructed in 1993. It suffered great damages due to the Kumamoto earthquake in April 2016. For example, slope failure caused the A1 abutment on the Tateno side of the bridge to subside, resulting in a gap of approximately 2 m between the abutment and the bridge girder. The earthquake also caused large cracks in the reinforced concrete piers.

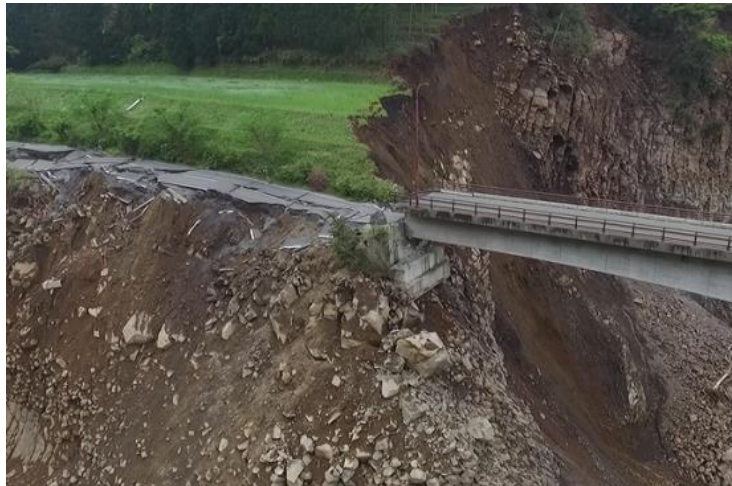
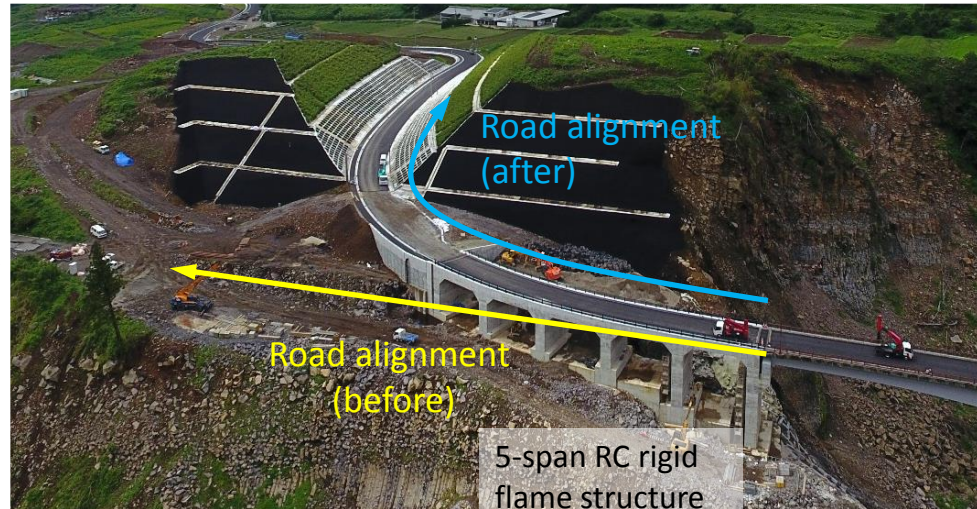
Restoration (Tateno side)

For example, on the Tateno side, the road alignment was changed to move away from the slope in order to reduce the impact on the road even if the slope were to collapse again. The bridge abutment was also reconstructed with a different structure .

In the process of restoration, various innovations were employed not only to restore the road to its original condition, but also to prevent similar damages in the event of a major earthquake in the future.

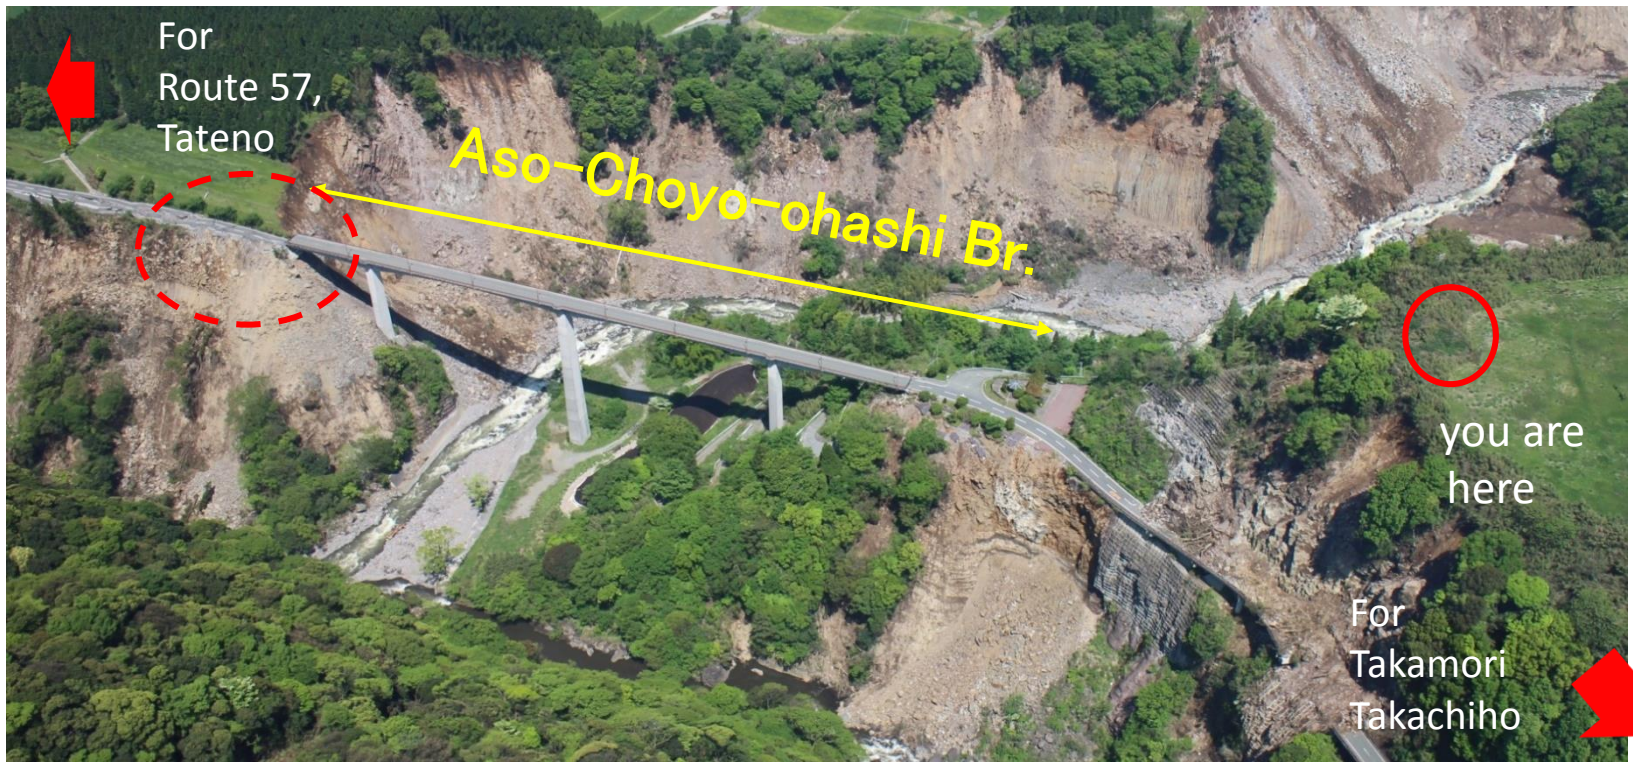
The Aso-Choyo-ohashi Bridge immediately after the damage caused by the Kumamoto Earthquake
